# Lucky Bay Shack Settlement – Coastal Review, Concept Option Development and Detailed Design Coastal Processes and Concept Design Report (DRAFT)

December 2013

Project Name:	Lucky Bay Shack Settlement – Coastal Review, Concept Option Development and Detailed Design
Project Number:	3005345
Report for:	District Council of Franklin Harbour

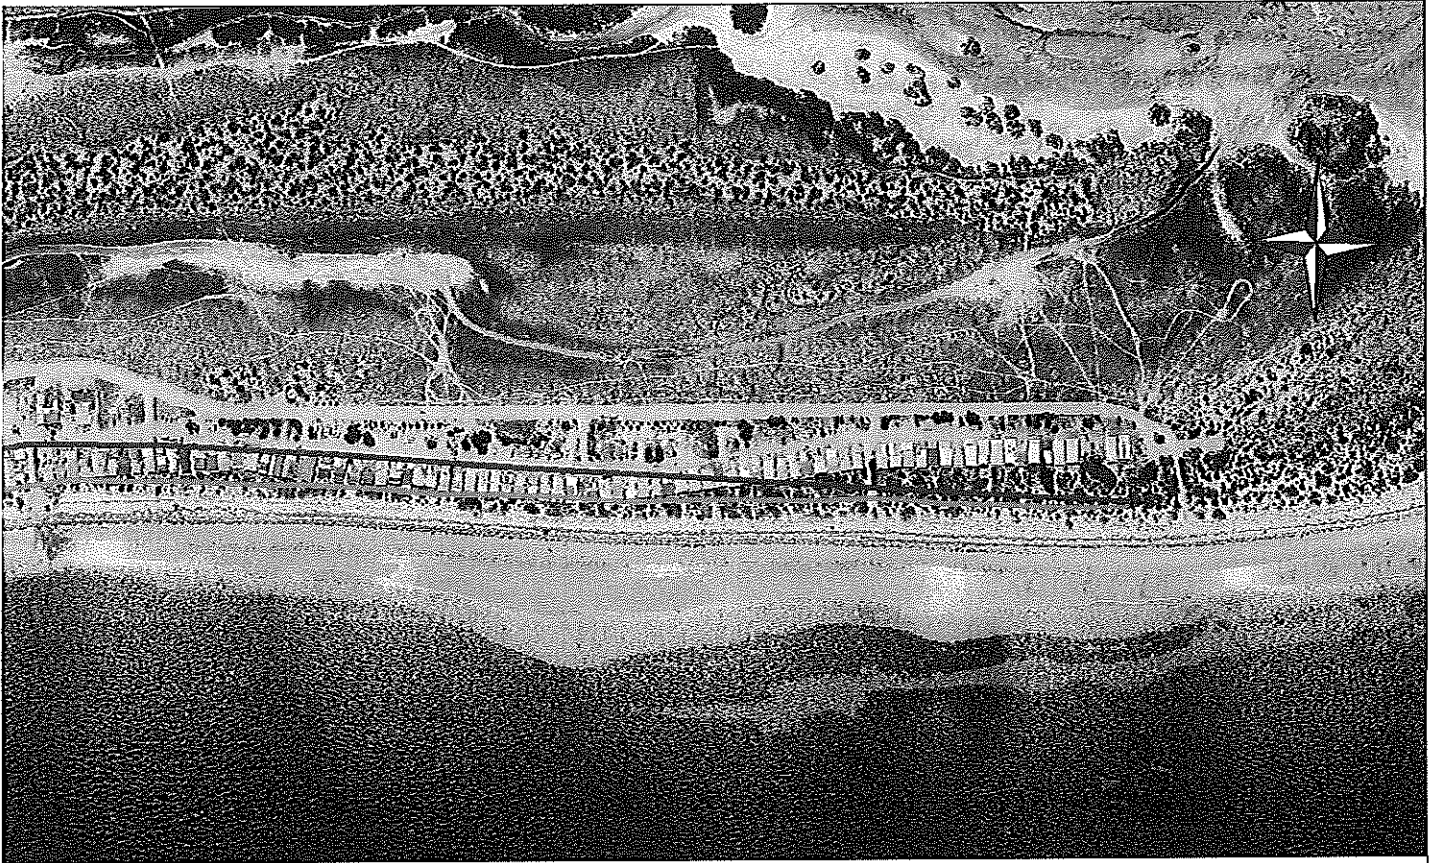
Beach erosion and shoreline recession are the two most significant coastline hazards that have the potential to affect the shacks at Lucky Bay. These two hazards have been reviewed and the position of coastal hazard lines<sup>1</sup> mapped for the shack settlement. **Figure 5** presents the immediate and the 2050 hazard lines resulting from this assessment.

As indicated in **Figure 5**, 45 shacks are expected to be impacted by the immediate hazard line with 93 shack expected to be impacted by the 2050 hazard line. At present shacks most threatened by coastal erosion hazard are in the eastern and middle sections of Lucky Bay, while by 2060 the entire eastern sector is threatened (see **Figure 5**).

—— IMMEDIATE HAZARD  
LINE

—— 2050 HAZARD  
LINE

<sup>1</sup> Coastal hazard lines are used to identify areas that are at risk from coastal hazards such as storm erosion. Here the immediate coastal hazard line is defined as the position of the landward setback to the top of the storm erosion scarp, following a coastal storm with an average recurrence interval (ARI) of 100-years. The 2050 coastal hazard line is defined as the position of the top of the storm erosion scarp following a 100-year ARI coastal storm occurring around the year 2050. The 2050 coastal hazard line includes an allowance for shoreline recession between now and 2050.

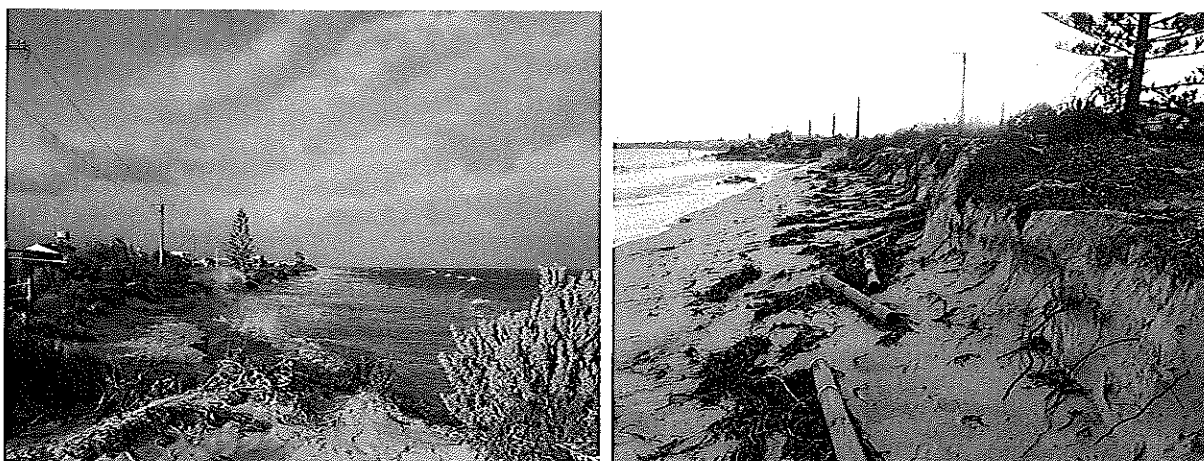
Figure 6 Examples of Storm Erosion May 2010 (area east of boat ramp)

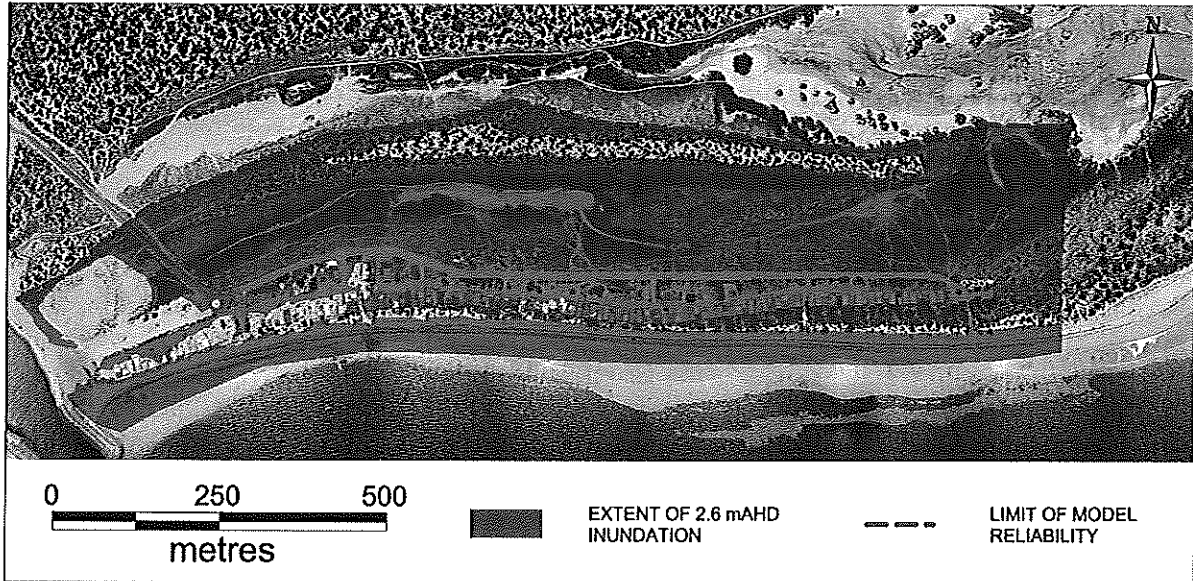
In the event of a large storm surge and high tide, 94 shacks are expected to be threatened by the coastal inundation over the 2050 planning period. Based on a recent survey of the shacks floor levels, the average depth of flooding is expected to be around 0.4 m. The entire western sector is most threatened by coastal inundation hazard (see **Figure 7**).

Figure 7 2050 Inundation Extents for 100-year ARI Event (includes 0.3 m of SLR)

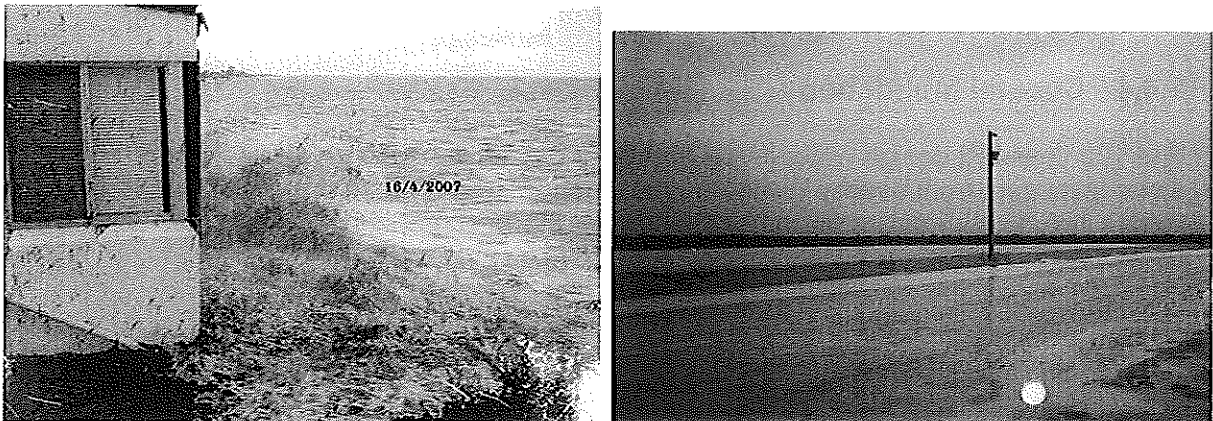
Figure 8 Examples of Lucky Bay Coastal Inundation (left: from the coast and right : from the tidal inlet)

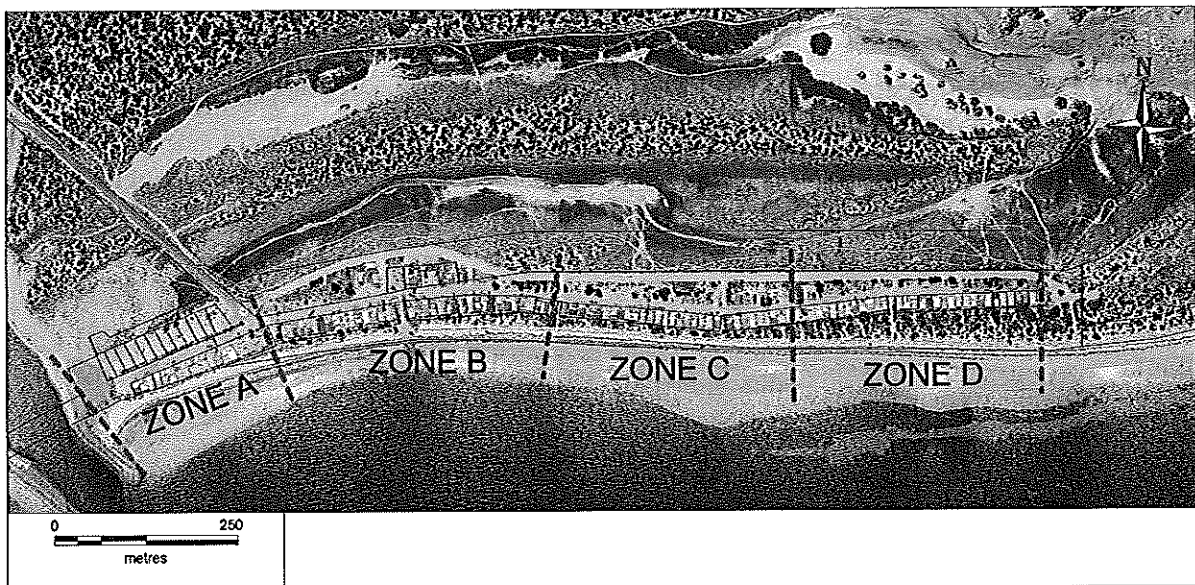
Observations and insights gained through the site visit, including a selection of site visit photographs, are provided below for each of the defined foreshore zones, see **Figure 9**.

**Figure 9 Lucky Bay Beach Management Zones**

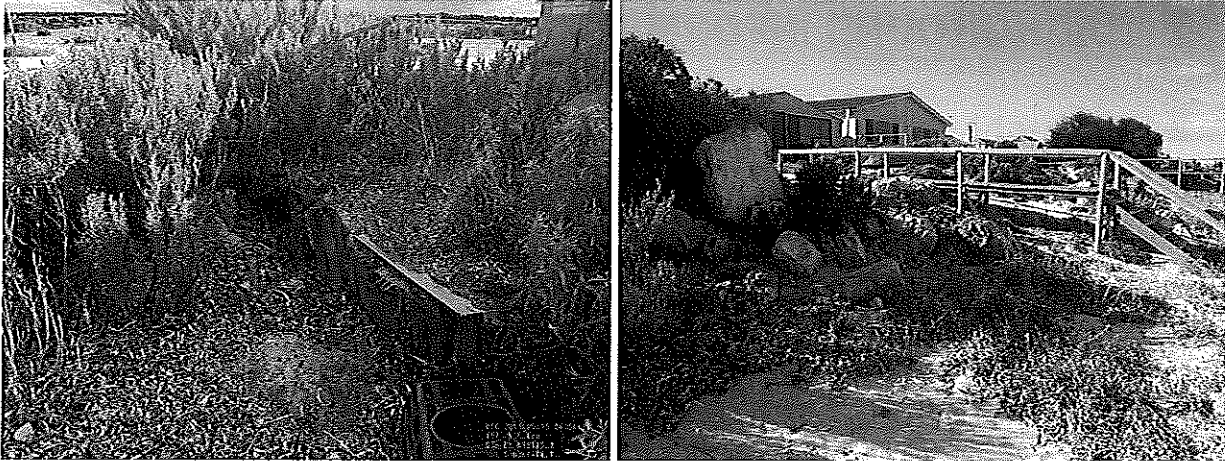
- Beach in a healthy state with an incipient dune and vegetation regrowth.
- Presence of *ad hoc* protection measures (hay bales, vertical timber seawall, dumped rock walls etc.) indicates historical foreshore erosion.
- Elevated (piled) beach access structures (redundant) are also present (see **Figure 10**).

Figure 10 Ad Hoc Protection Measures and Timber Beach Accessway

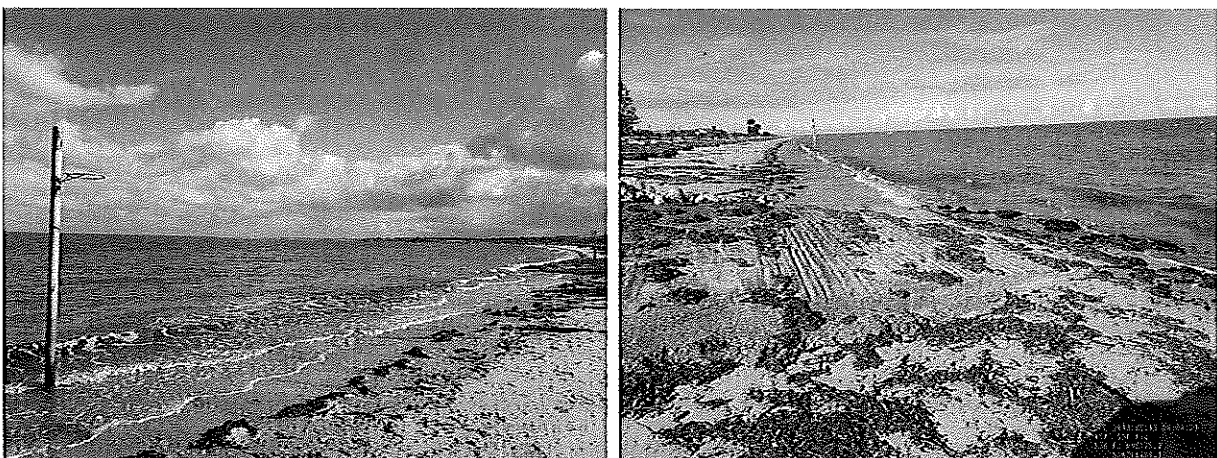
- Coastal erosion evident with significant lowering of the beach profile.
- Change in observable sediment characteristics, i.e. more shell grit and gravel.
- Boat ramp is a shoreface sediment control point with sand accumulating on the western side of the ramp, and on the eastern side a lower beach level and incipient foredune. Hard rock protection on either side of the boat ramp, possibly indicating previous undermining due to storm erosion.
- Navigation aids (netball posts) for boat ramp located in swash zone (see Figure 11).
- Eastern shacks aligned further from the shoreline in this zone.
- Appeared to be reduction in incipient dune height

Figure 11 Goal Posts and Boat Ramp

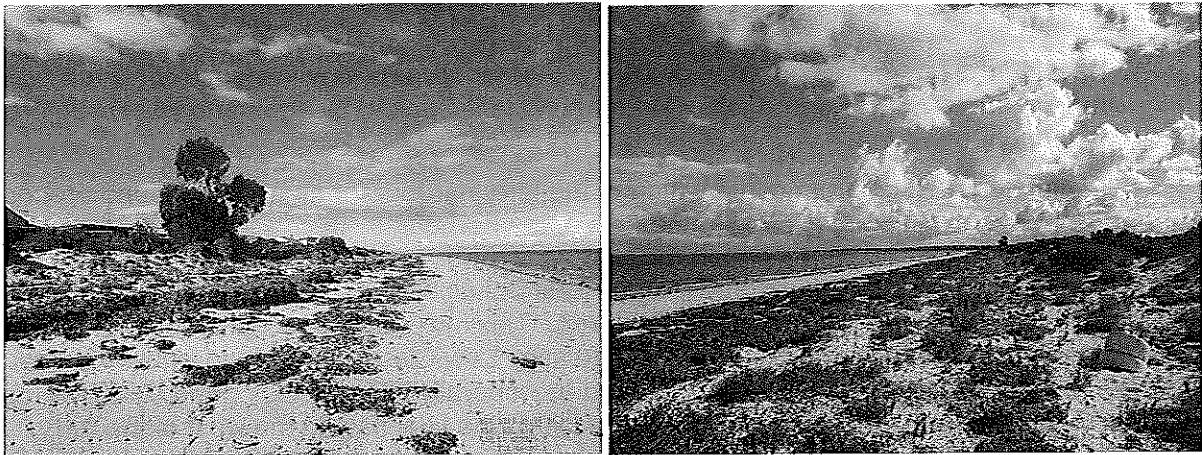
- Shack setback from the foreshore increases at the eastern end of this zone.
- Some shacks are aligned close to the shore.
- Mature eucalypt stands on dune crest (estimated to be 30 years old, see **Figure 12**), with lower branches chopped off, possibly dying.
- Some evidence of what appears to be beach replenishment seaward of the foredune which is slowly being revegetated.

**Figure 12 Mature Eucalypts and Dune Revegetation**

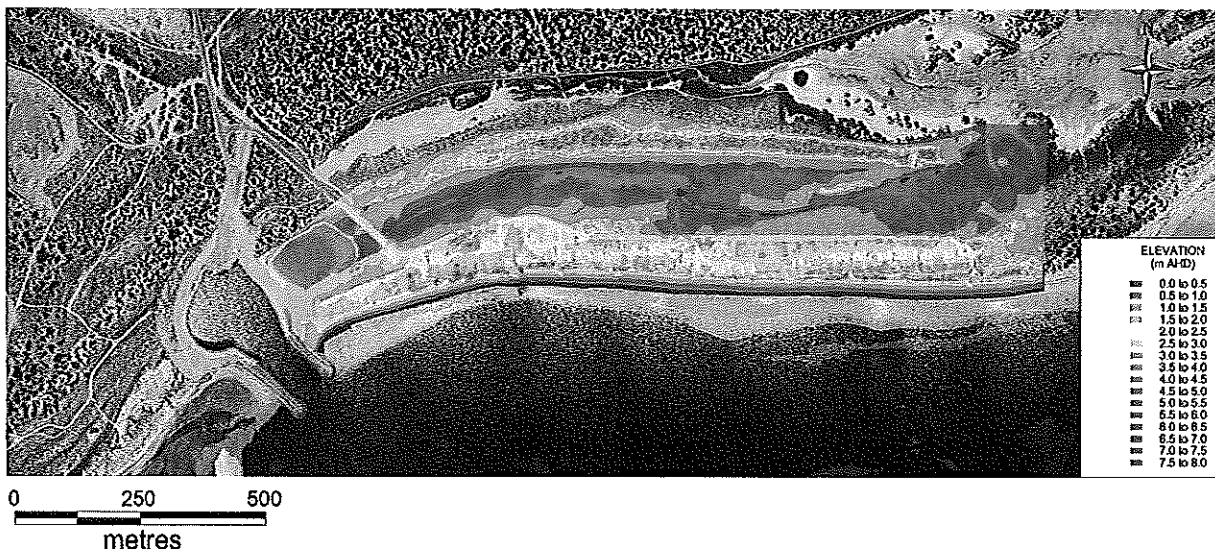
Figure 13 Lucky Bay Topography (based on survey by Andrew and Associates, 2012)

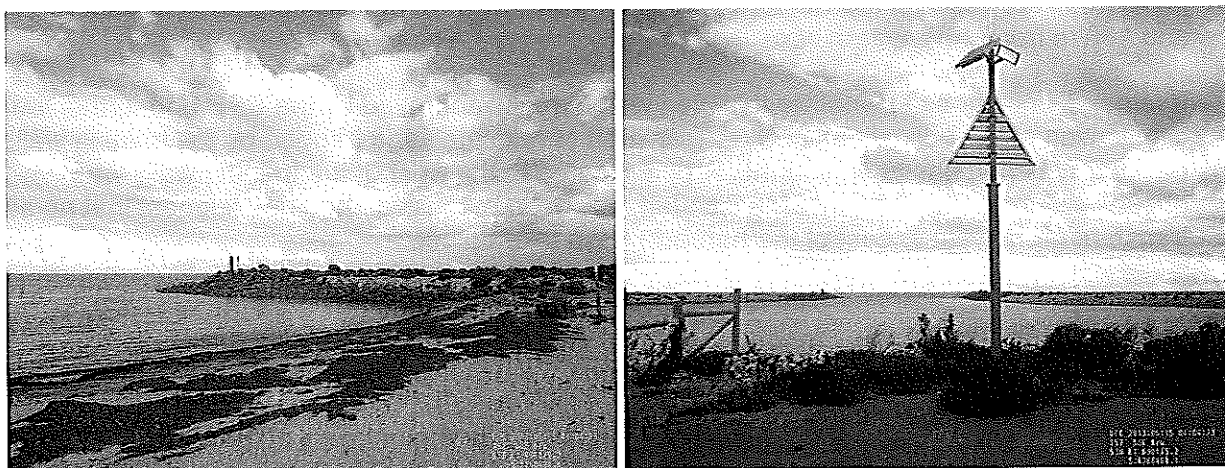
**Figure 16 Eastern Training Wall and Ferry Harbour**

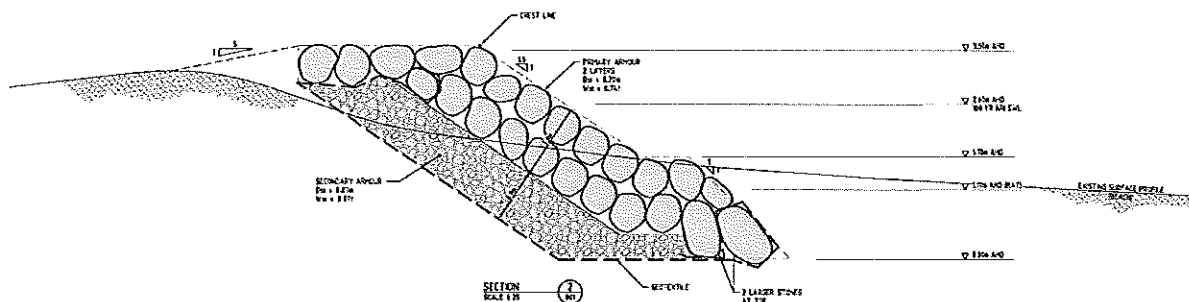
Using established coastal design methods, a concept design has been completed for the rock revetment. It would be designed to provide coastal protection up to the 100 year ARI design storm event. Provided appropriate maintenance was carried out, the design life of the structure would be 50 years. Based on preliminary design calculations, **Appendix B** presents a general arrangement and typical cross sections for the proposed revetment option. A typical section is shown in **Figure 17**.

**Figure 17** Typical Revetment Cross-Section

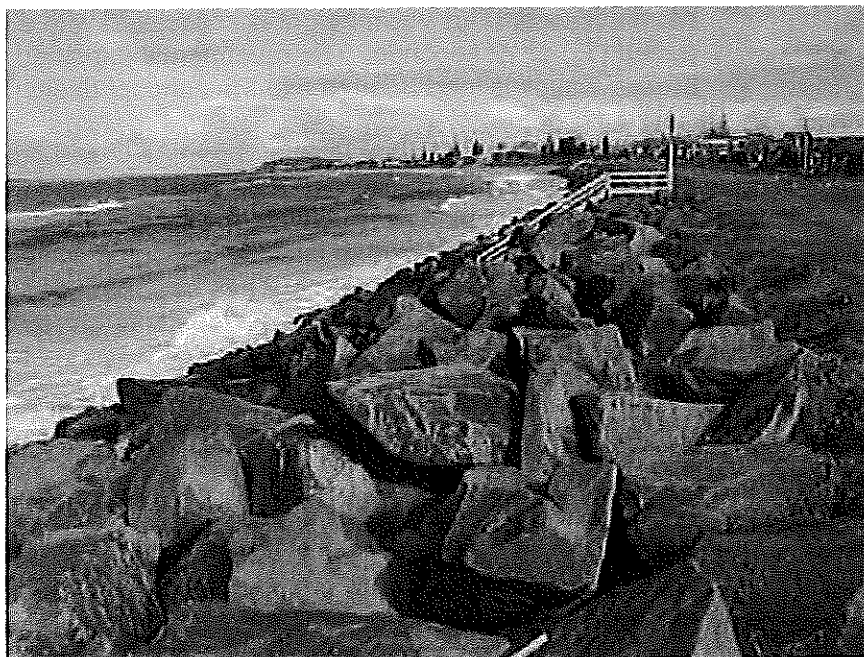
however, as the shoreline recedes in response to rising sea levels and ongoing sediment loss, the beach would be lost. See **Figure 18** as an example.

**Figure 18** Example of rock revetment with no beach at high tide (Stockton Beach, NSW)

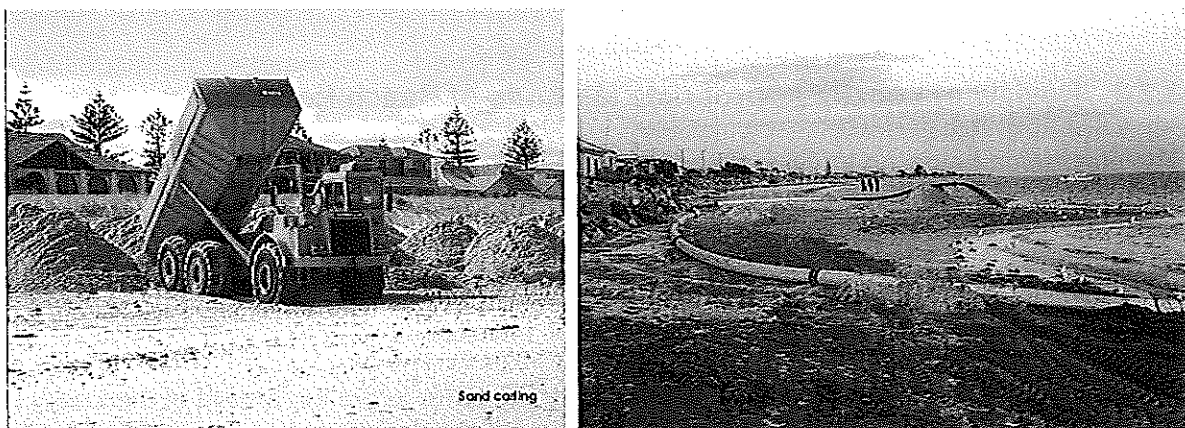
Beach nourishment involves placement of beach sand on the upper beach face and dune, to re-establish a sandy beach after a storm and to provide a sediment supply for subsequent storm events. **Figure 19** shows local examples of beach nourishment works in progress.

**Figure 19** Examples of beach nourishment (left : Adelaide beach using sand carting and right – Lucky Bay using a dredge and pipeline).

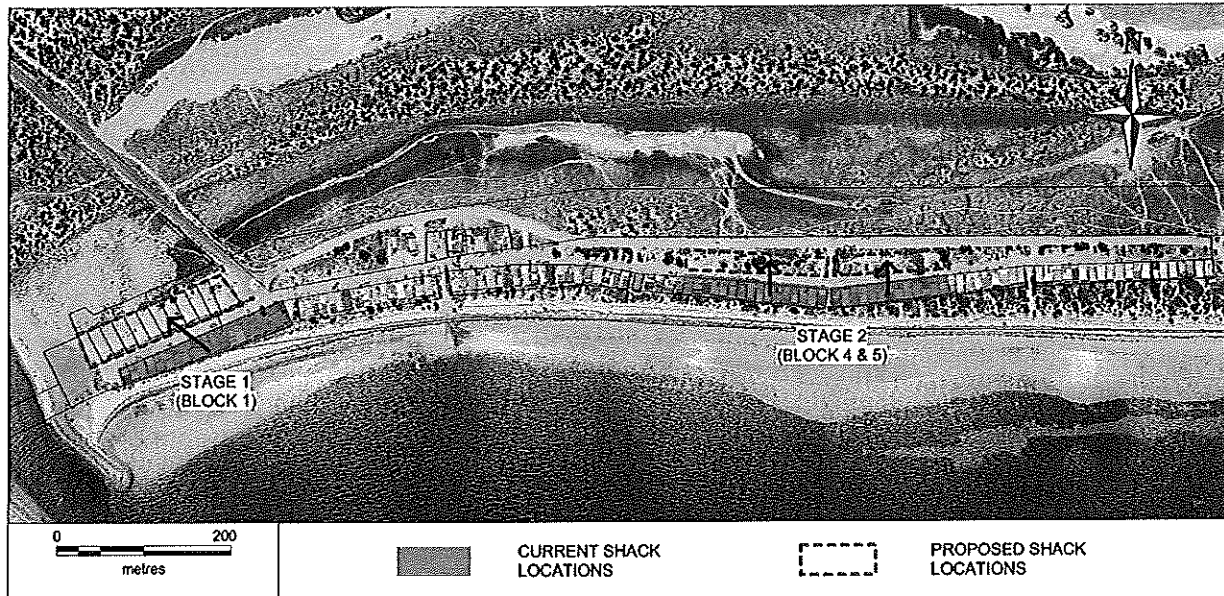
Figure 22 Staged Shack Relocation Proposed at Lucky Bay

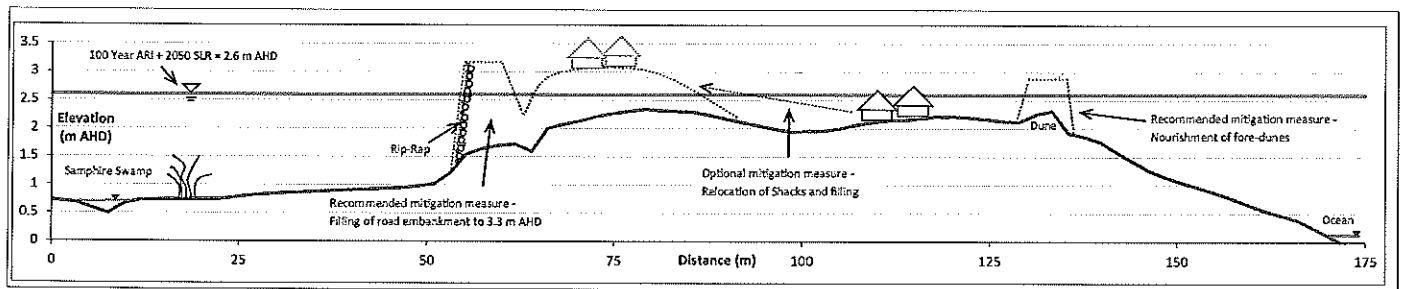
Stormwater drainage would need to be provided between the shack area and the tidal inlet. Rubber duckbill valves should be fitted to the end of stormwater outlets so that backflow from the inlet during times of storm surge and high tide is eliminated while allowing stormwater to drain at all other times. Consideration of expected rainfall/runoff volumes and durations, along with coincident flooding (i.e. rainfall and storm surge combined) would need to be considered in the detailed design stage to ensure drainage measures were adequate.

Figure 23 Potential Mitigation Measures

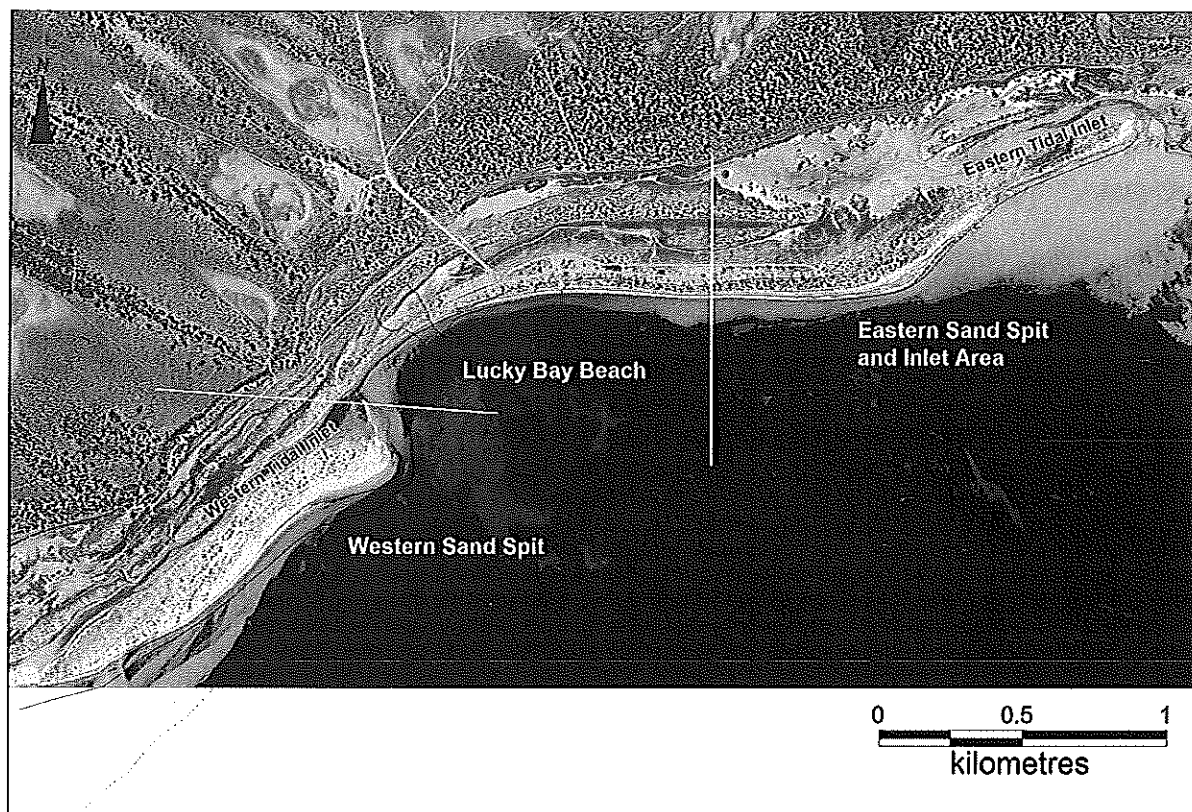
Figure 24 Lucky Bay Coastal Compartments

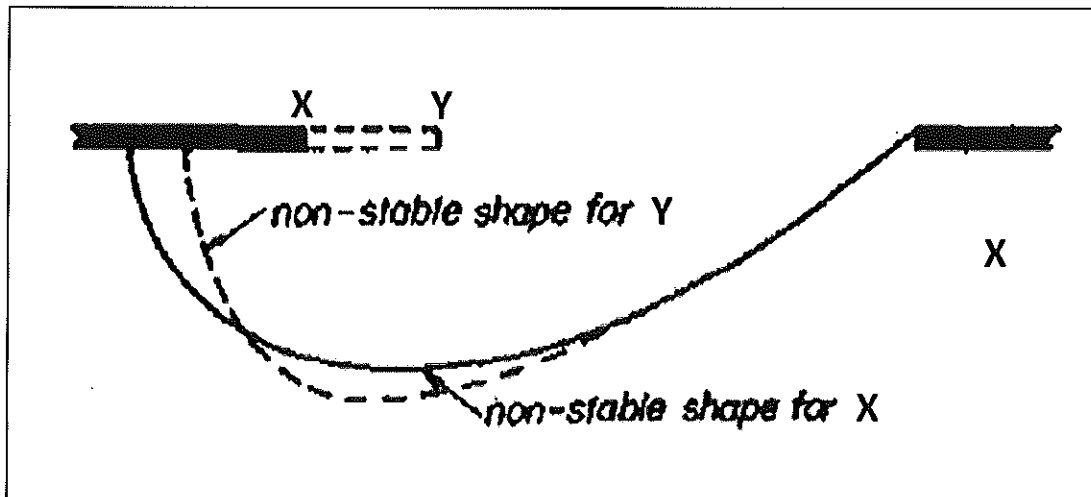
- As a secondary process to the net loss of sediments within this compartment it is possible that as the 'sand headland' extends east, the 'zeta' or log-spiral shape embayment in the lee of this headland changes (i.e. Lucky Bay beach shoreline) as per Figure 25 below from Silvester *et al* 1978. This behaviour would result in a drift of the worst sort of erosion to the east for Lucky Bay, as has been observed.

Figure 25 Effect on shoreline within embayment when headland control extends from A to B

- The introduction of the training walls is expected to alter the zeta embayment shape as per **Figure 25** (after Silvester *et al*, 1978). It is likely that erosion in **Zone A** of Lucky Beach will start to slow as it reaches a new stable alignment, seaward of its previous (pre-construction) alignment, see area X below in **Figure 27**.

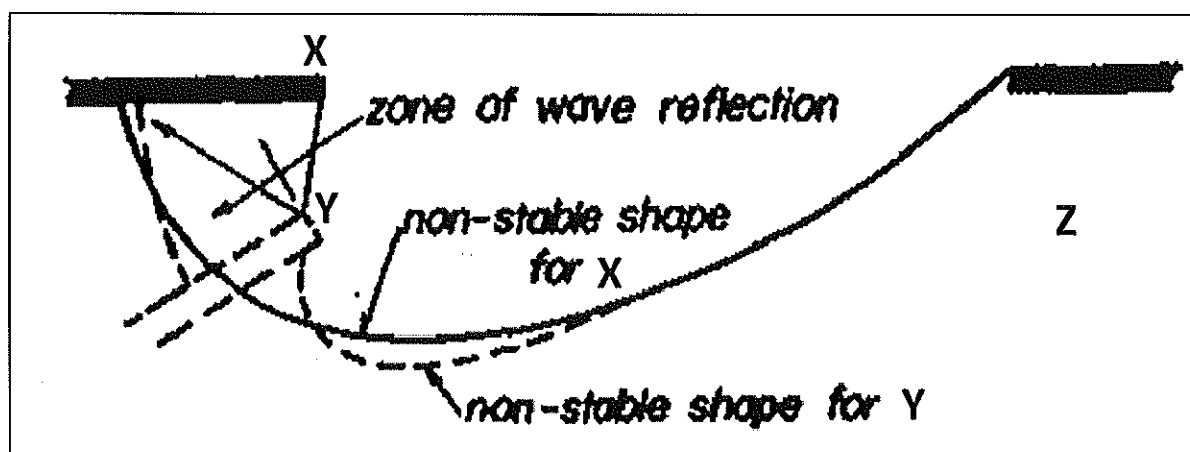
**Figure 27** Effect on shoreline within embayment when a new structure, such as training walls, moves the control point from A to B.

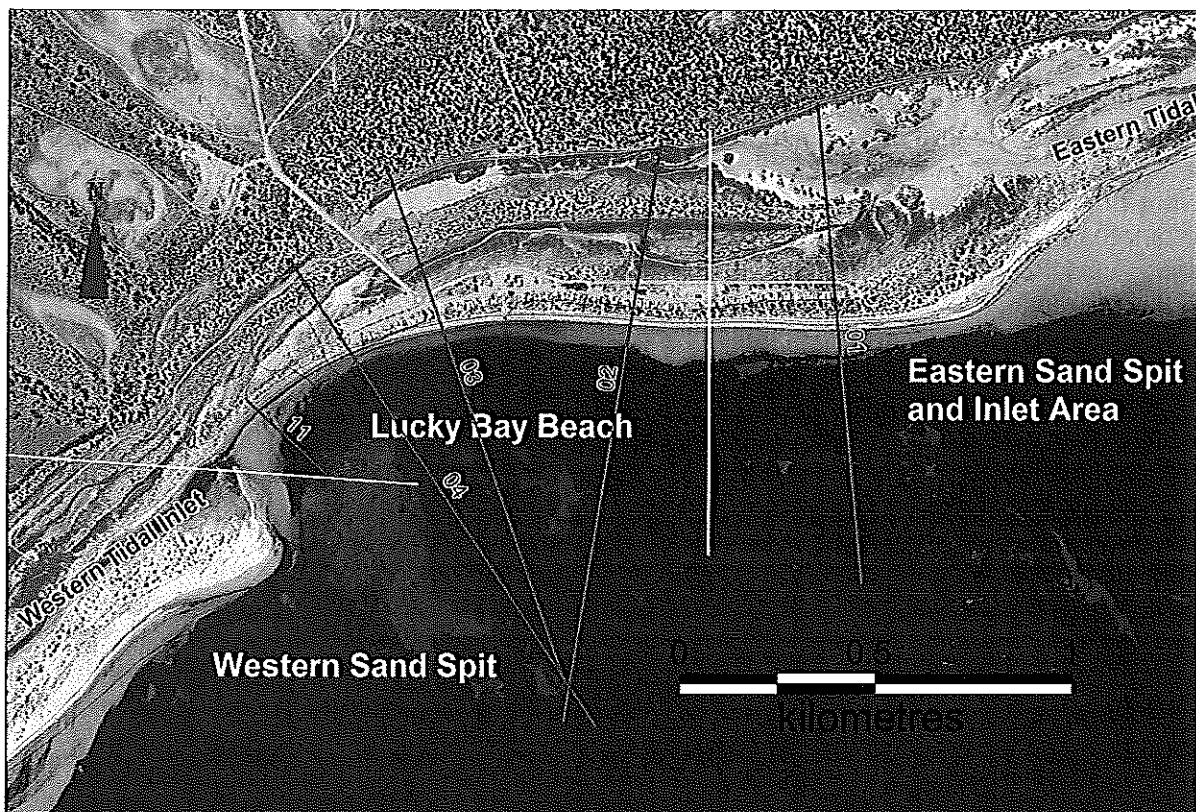
Figure 31 Location of the selected CBP beach profiles at Lucky Bay (2004 aerial in background).

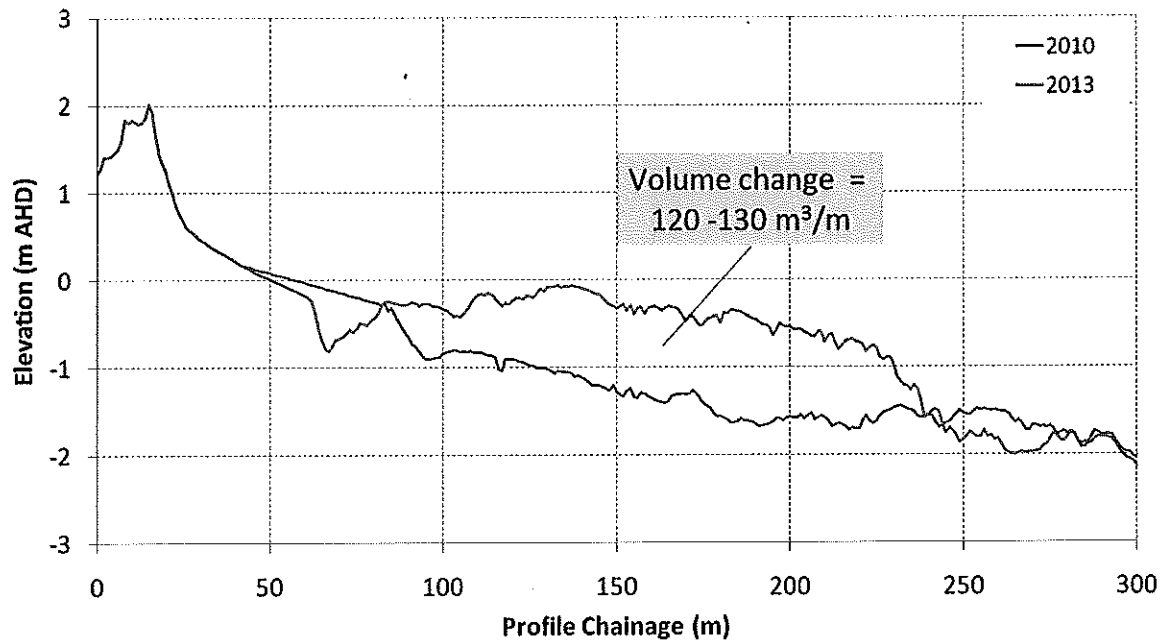
Figure 34 CBP-11 Plotted for 2010 to 2013

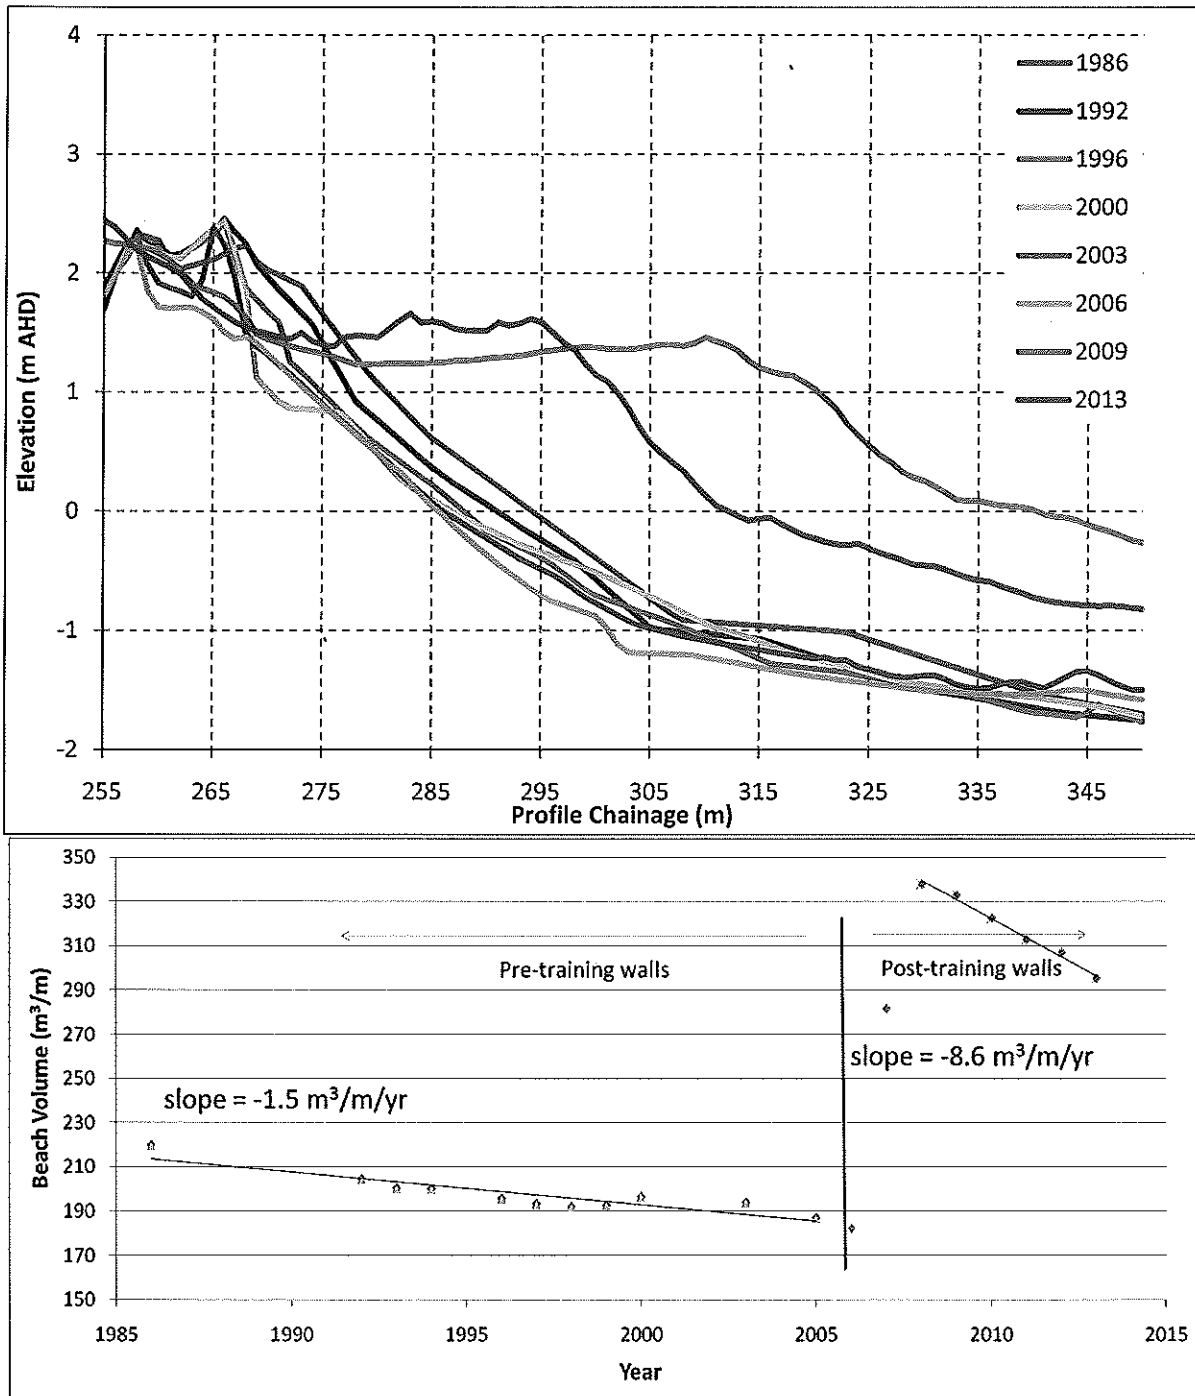
Figure 35 Top - CPB profile 04 from 1986 to 2013. Note: for clarity not all beach profiles are plotted, Bottom - Beach volume trend for CPB profile 04.

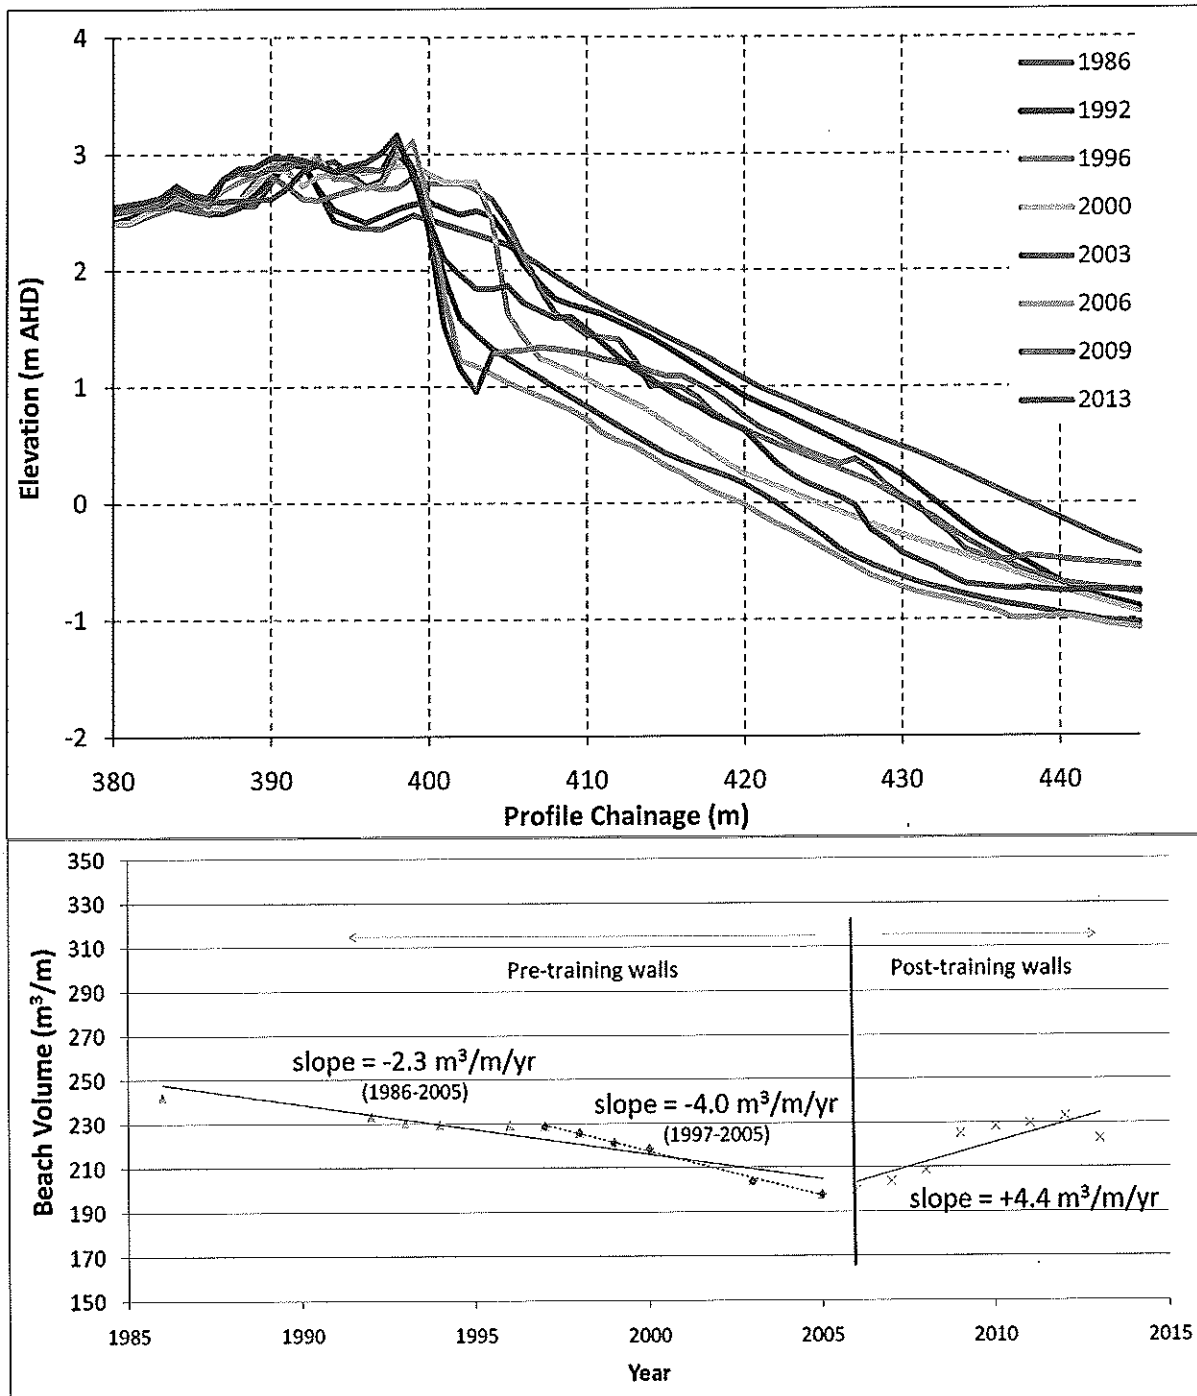
Figure 36 Top - CPB profile 03 from 1986 to 2013. Note: for clarity not all beach profiles are plotted, Bottom - Beach volume trend for CPB profile 03.

The recent accretion at CPB profile 03 is evidence of the material placed as part of the renourishment has been moving east, changing the trend of this area of the beach from eroding to accreting. The renourishment will continue to move to the east and will start to result in accretion at the mid-section of Lucky Bay over the next few years. Recent erosion (2012-2013) could be the way of the future as the capital nourishment has run its course and the trend of erosion is likely to restart, possibly at a more rapid rate than before construction.

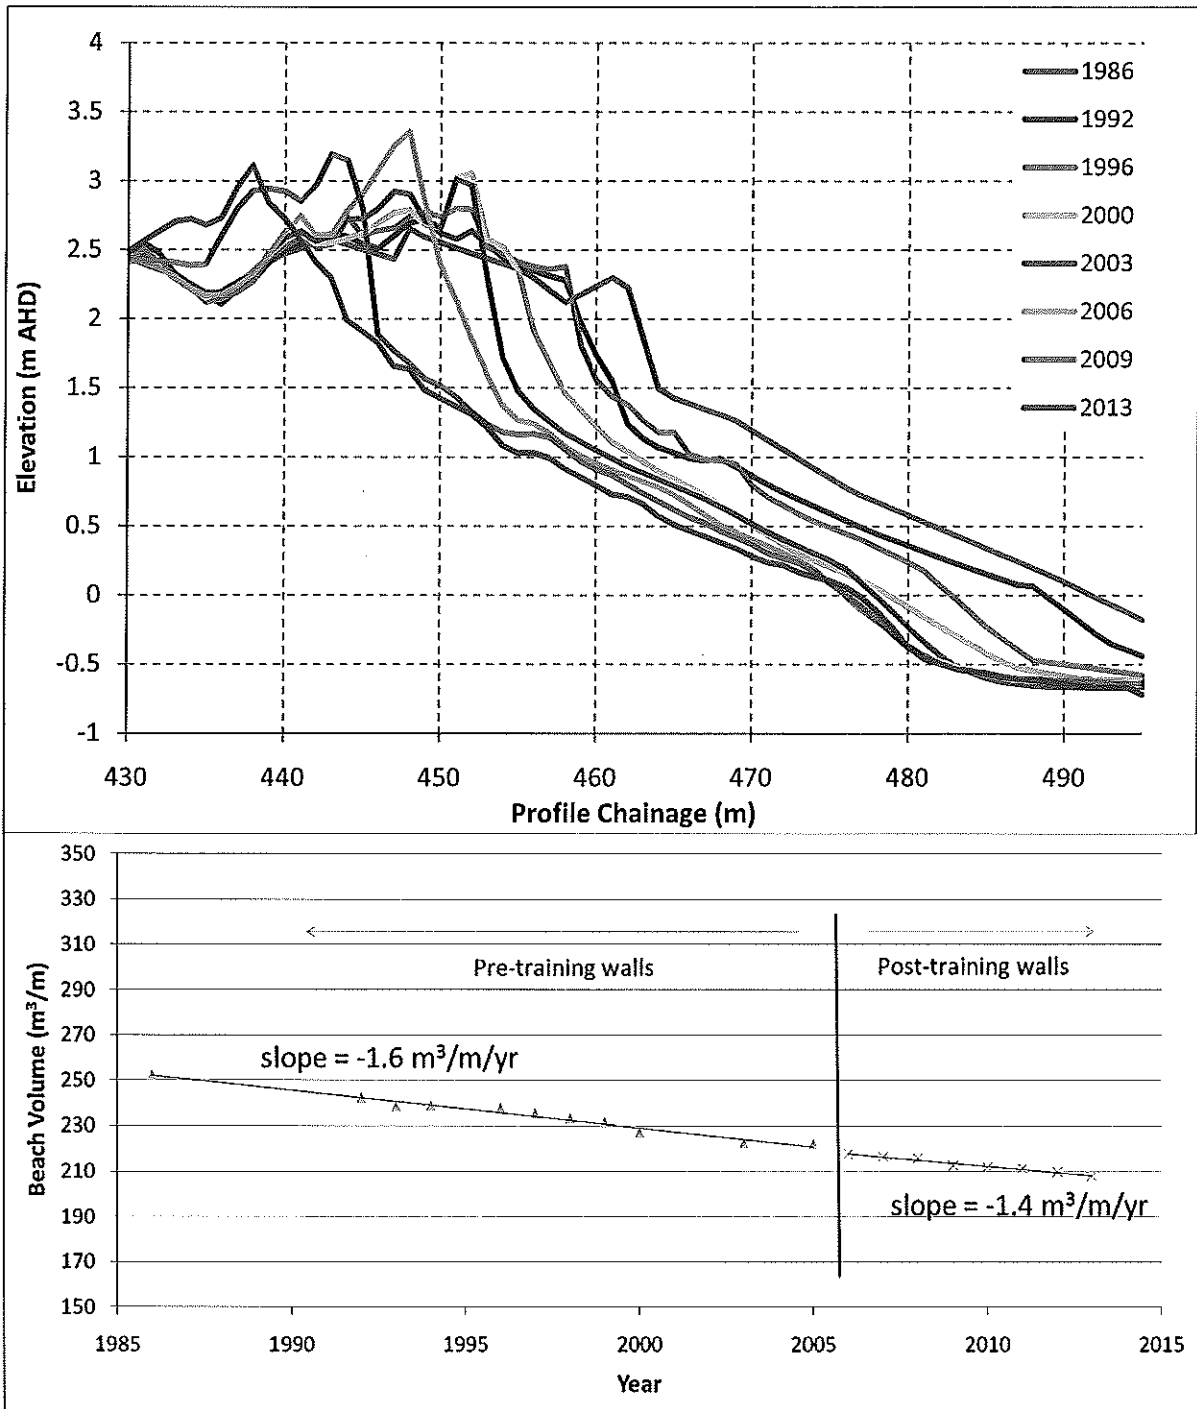
Figure 37 Top - CPB profile 02 from 1986 to 2013. Note: for clarity not all beach profiles are plotted, Bottom - Beach volume trend for CPB profile 02.

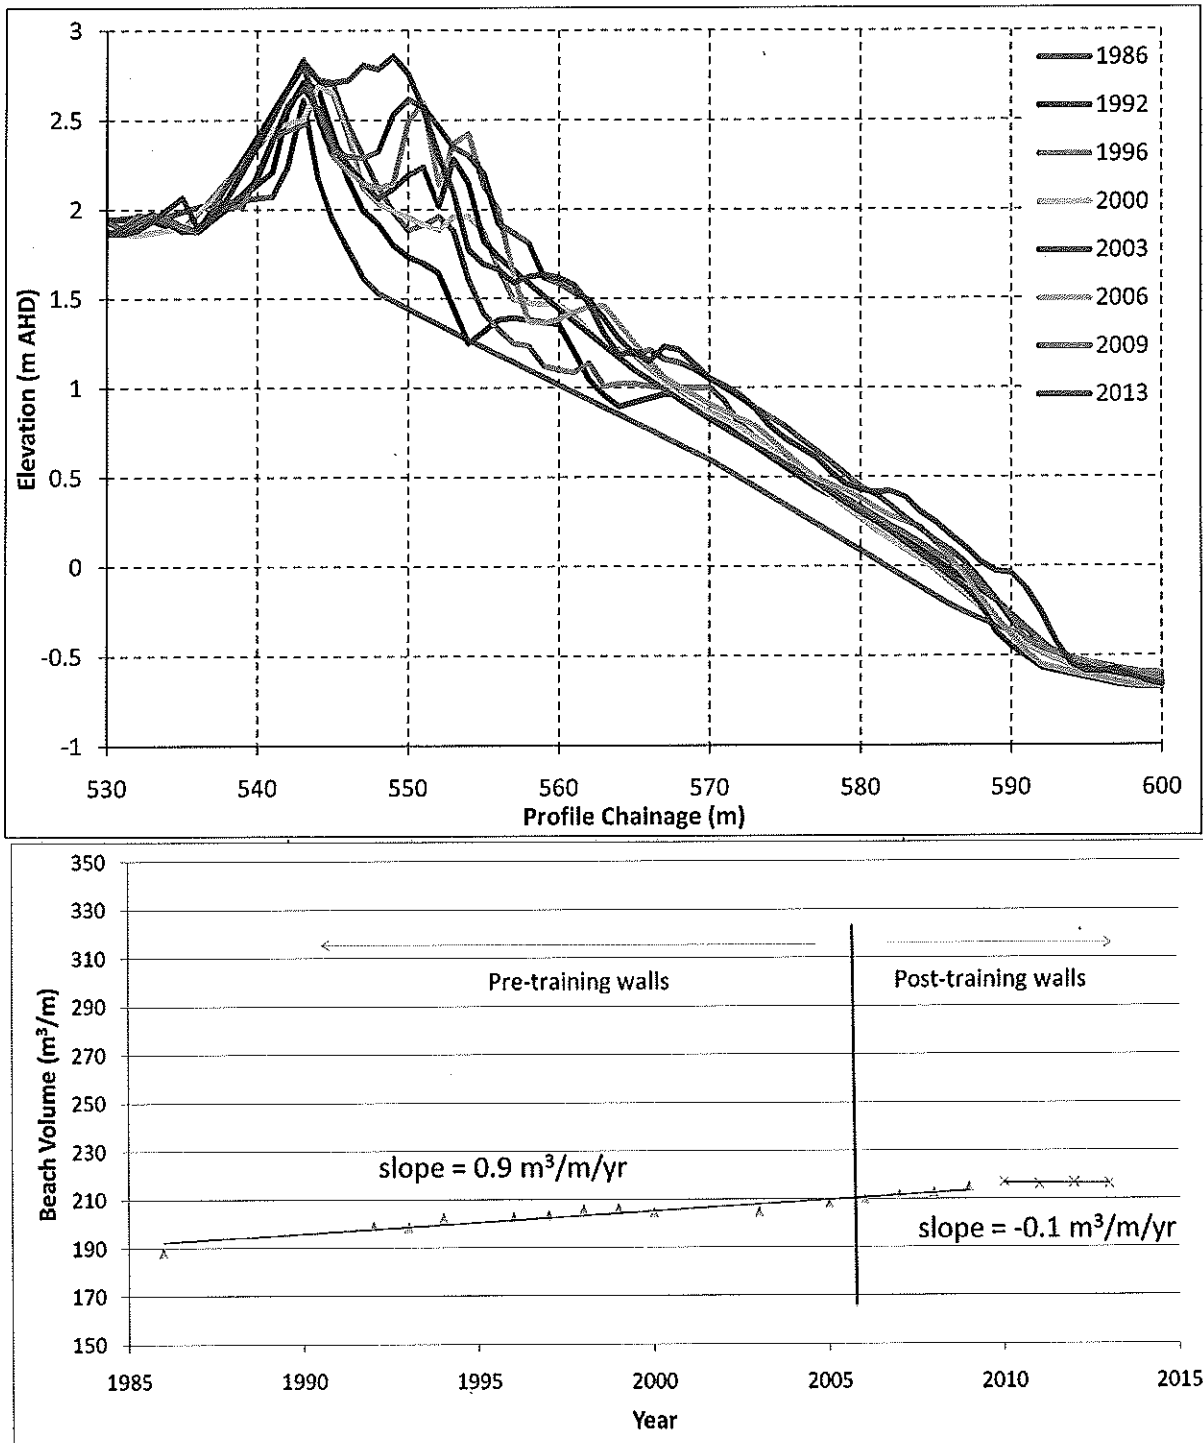
Figure 39 Top - CPB profile 01 from 1986 to 2013. Note: for clarity not all beach profiles are plotted, Bottom - Beach volume trend for CPB profile 01.

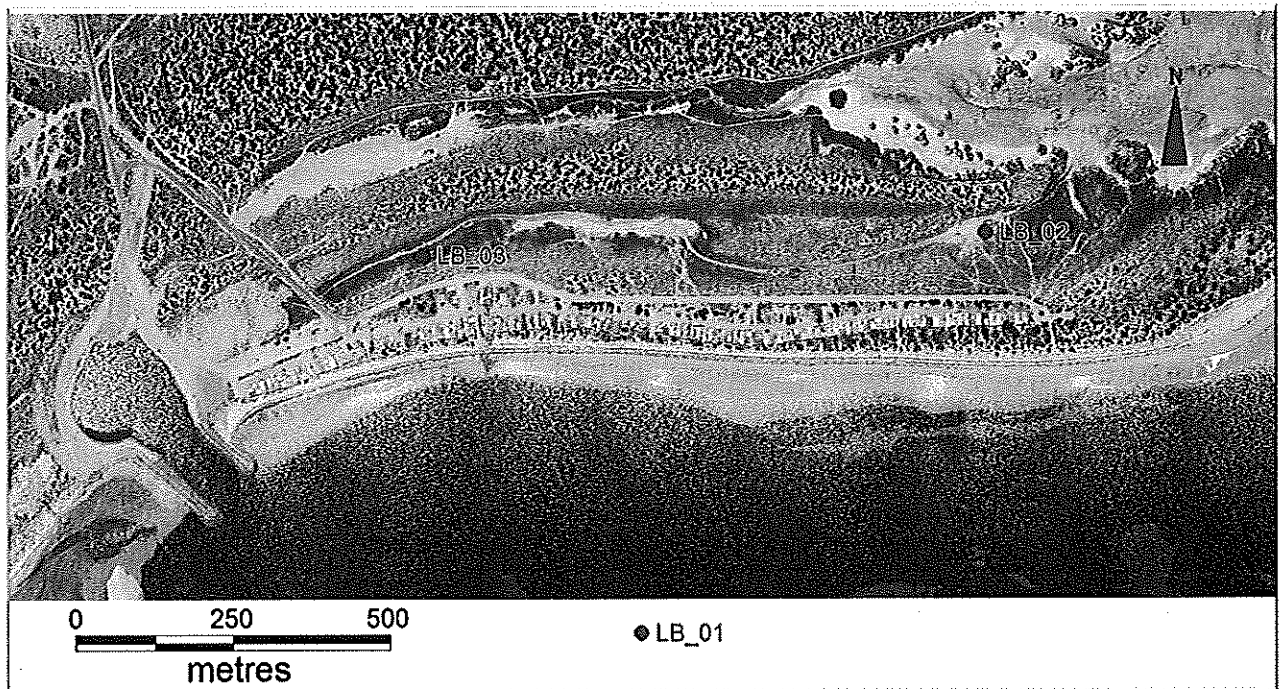
**Figure 40** Lucky Bay measurement site locations
