# Lucky Bay Shack Settlement – Coastal Review, Concept Option Development and Detailed Design Coastal Processes and Concept Design Report (DRAFT)

December 2013

Project Name:	Lucky Bay Shack Settlement – Coastal Review, Concept Option Development and Detailed Design
Project Number:	3005345
Report for:	District Council of Franklin Harbour

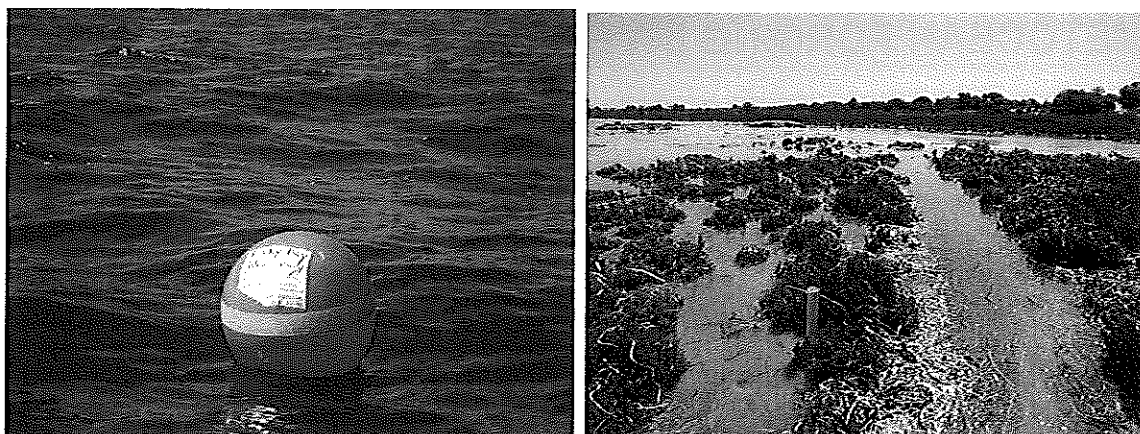
The deployment was undertaken on the 26 September 2013 and retrieval carried out on the 7 November 2013, all instruments were successfully retrieved without incident. **Figure 41** presents some images from the metocean data collection work.

Figure 41 Lucky Bay Wave Gauge (marker) and Samphire Swamp Water Level Gauge

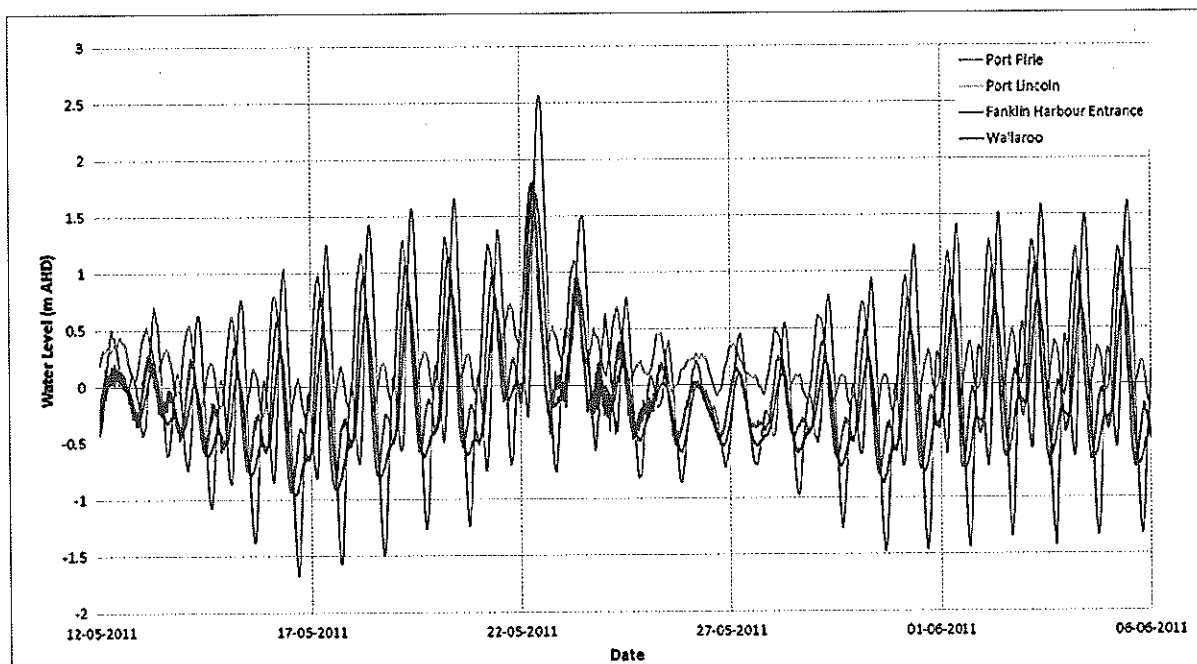
**Figure 42 Measured water levels at Port Lincoln, Franklin Harbour, Wallaroo and Port Pirie.**

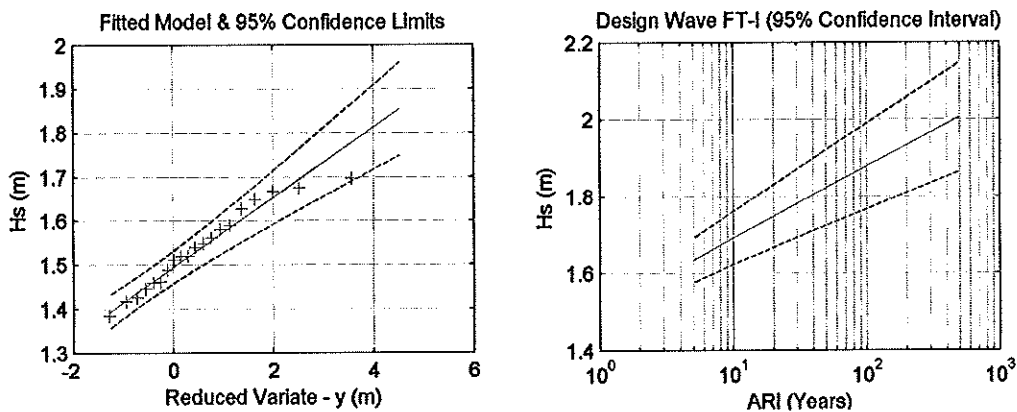
Figure 44 Fitted Extreme Value Model (left) and Water Level Design Curve (left) for Wallaroo Site (1996 to 2012).

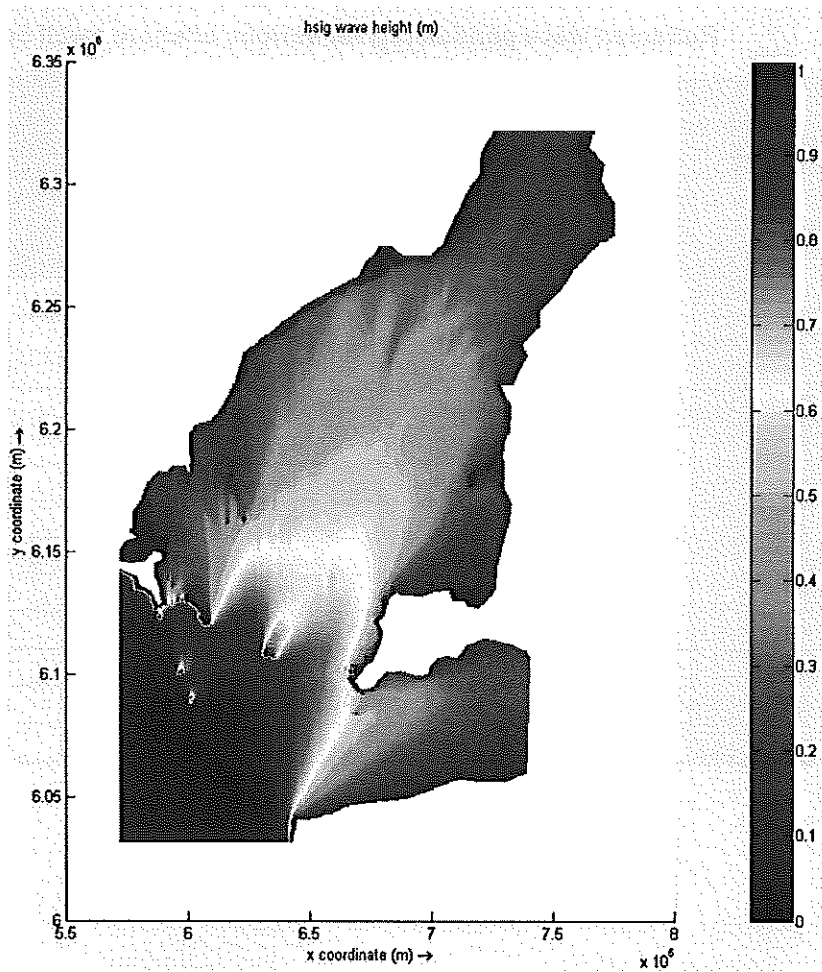
Figure 47                      SWAN results for  $H_s = 1m$ ,  $T_p = 8s$  and  $Dir = 202.5^\circ TN$  (SSW)

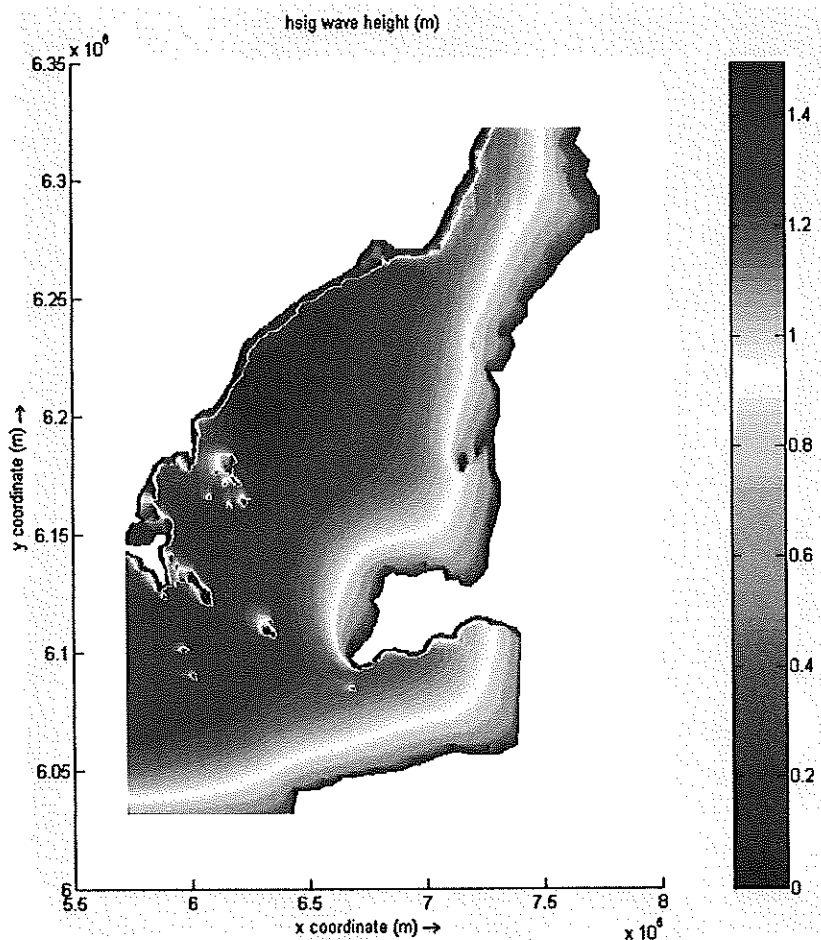
Figure 49 SWAN output for a wind speed of 10 m/s and a wind direction of 135°TN (SE)

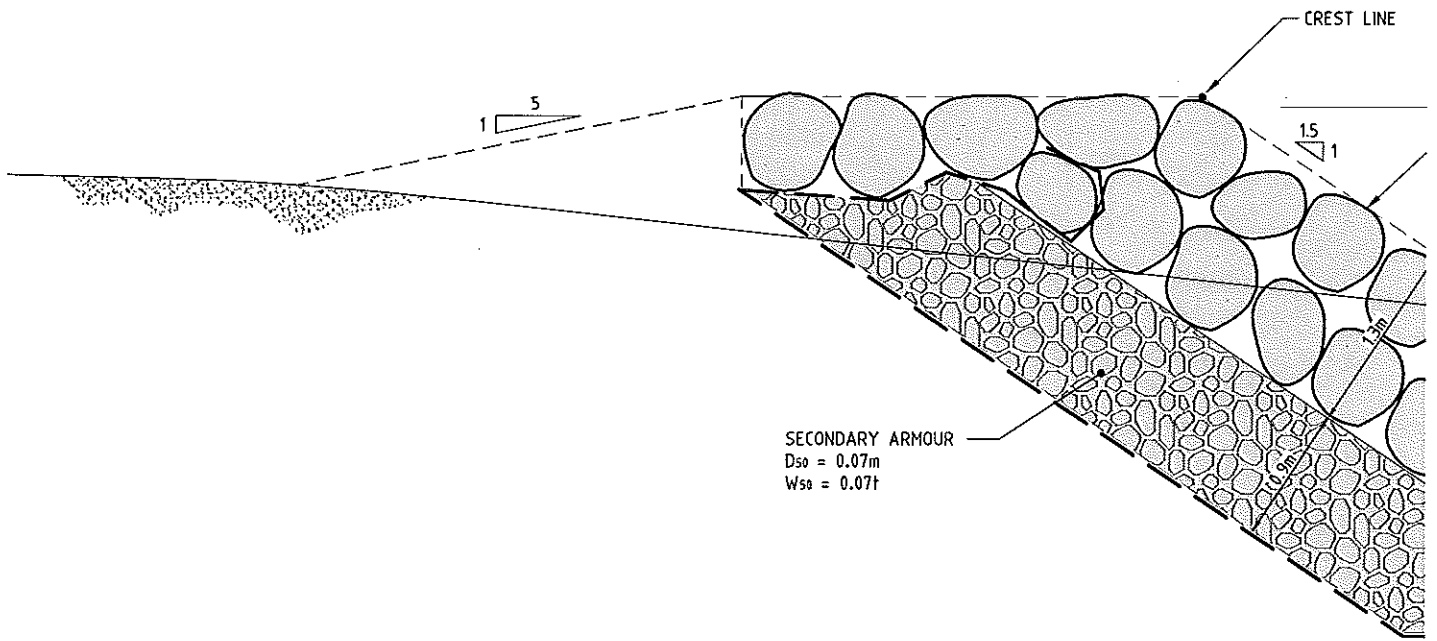
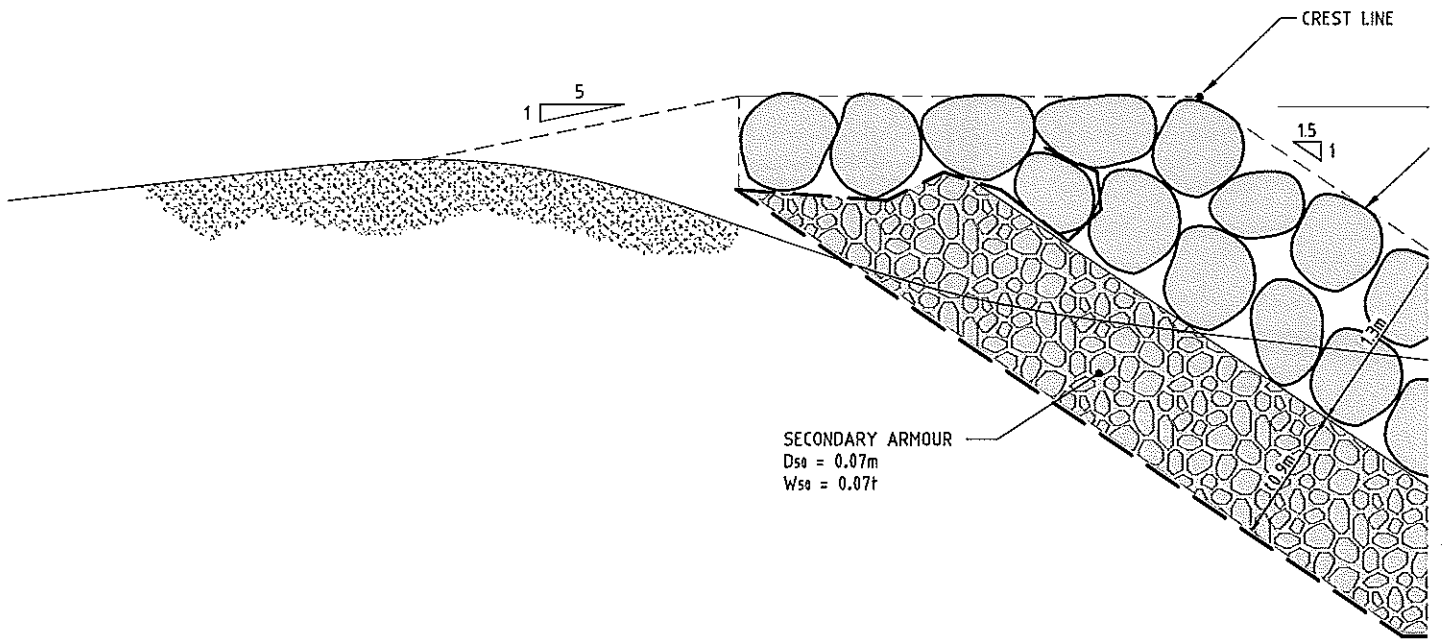
SECTION  
SCALE 1:25

**LUCKY BAY COASTAL F  
OPTION 1 - ROCK REVET**
